# Some lessons of more than 20 years of inspection, maintenance and rehabilitation of bridges in Spain

Francisco Millanes Mato

Ignacio Pulido Sánchez

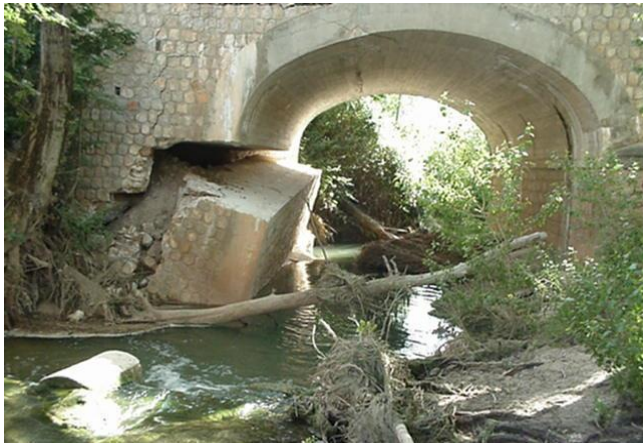
Figure 1. Scouring of foundations.

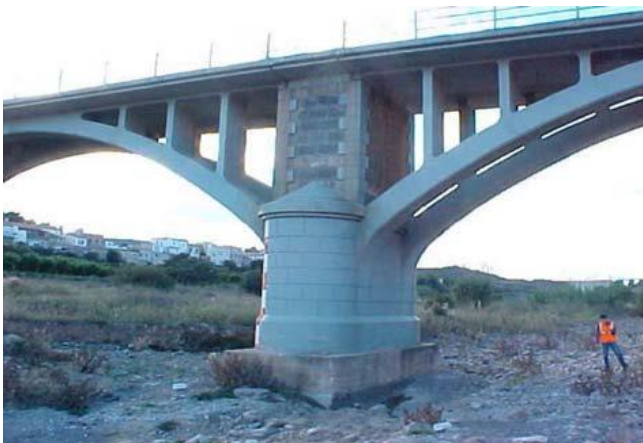
Figure 2. Scouring of foundations.

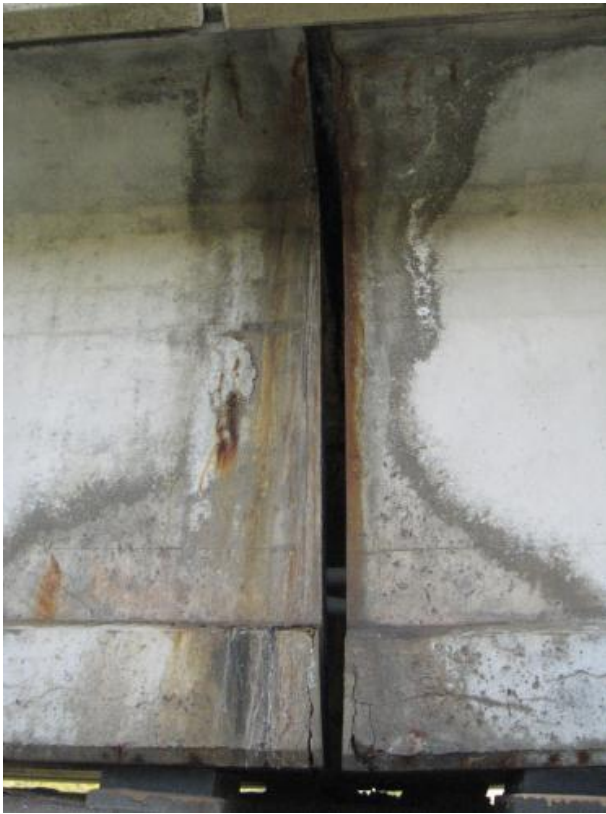
Figure 3. Water leakage through expansion joints.

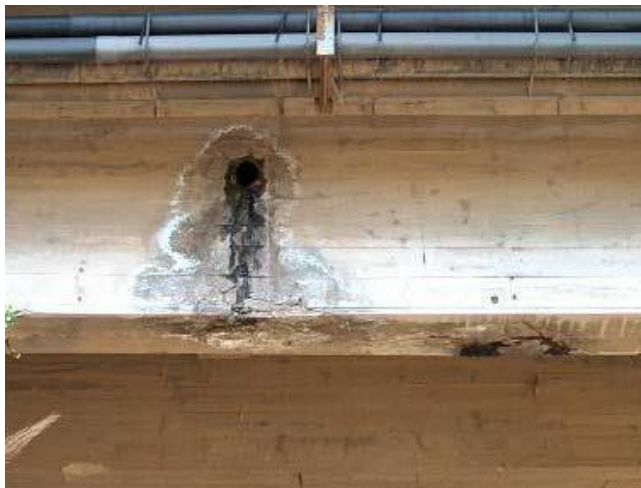
Figure 4. Missing elements in drains.

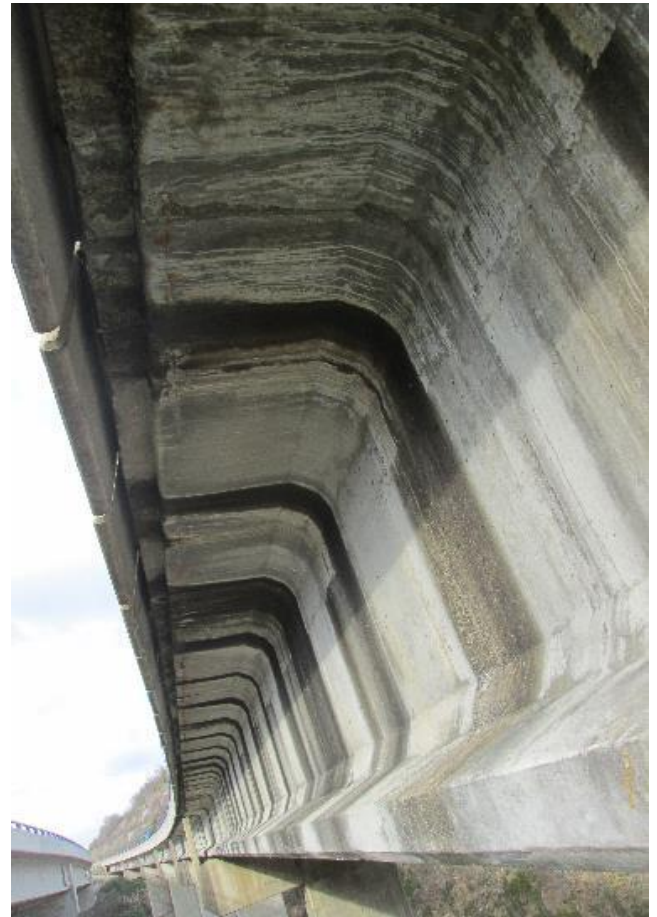
Figure 5. Water filtrations under the platform's side bars.

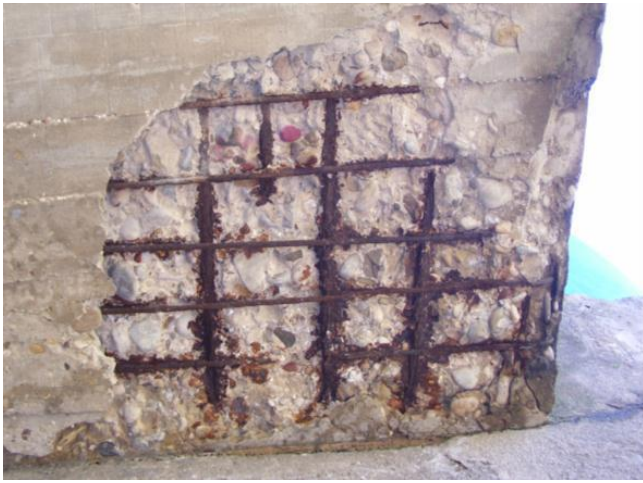
Figure 6. General corrosion due to concrete carbonation.

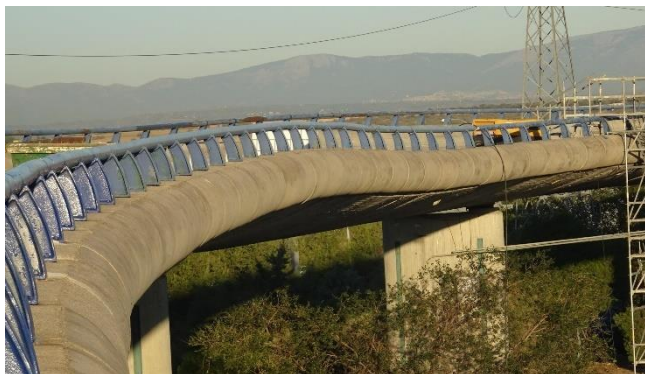
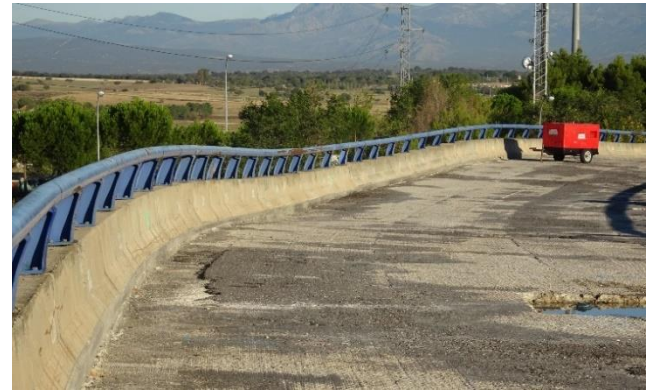
The structure inspection was undertaken when significant deviations from the deformed alignment with respect to the theoretical elevation were detected. Such inspection revealed serious alkali-aggregate reaction issues, having as a consequence an important reduction of up to 60% of the deformation modulus of concrete and intense expansion processes associated to general longitudinal cracking processes at the deck.

Figure 7a. Serious alterations at the alignment of the overpass located at Colmenar & M40 junction (Madrid).

Figure 7b. Serious alterations at the alignment of the overpass located at Colmenar & M40 junction (Madrid).

All this inevitably led to an immediate decommissioning of the structure and a subsequent deck demolition and replacement.

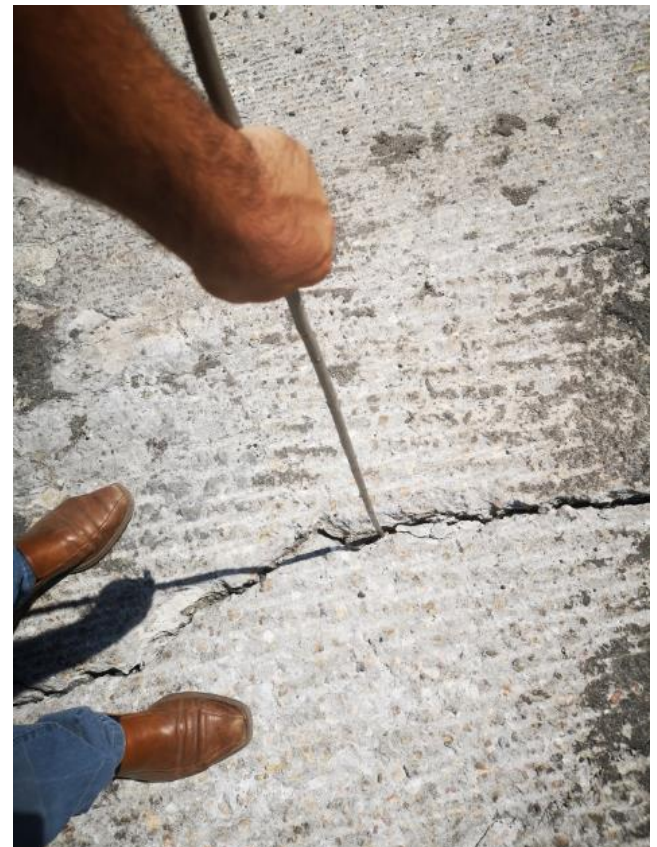
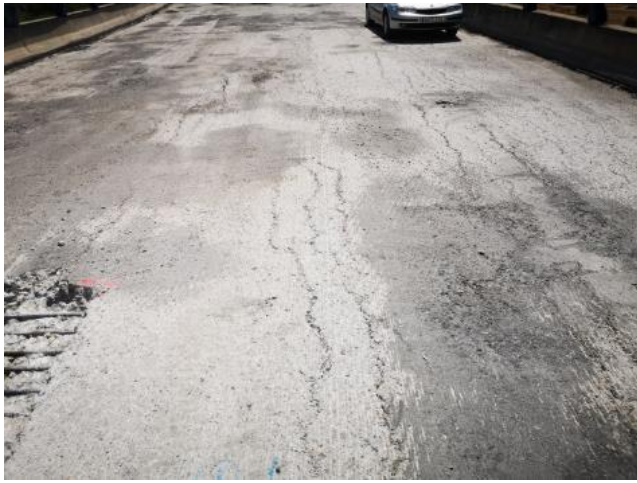
Figure 8a. Cracking and general longitudinal fissures due to alkali-aggregate reaction expansion processes.

Figure 8b. Cracking and general longitudinal fissures due to alkali-aggregate reaction expansion processes.

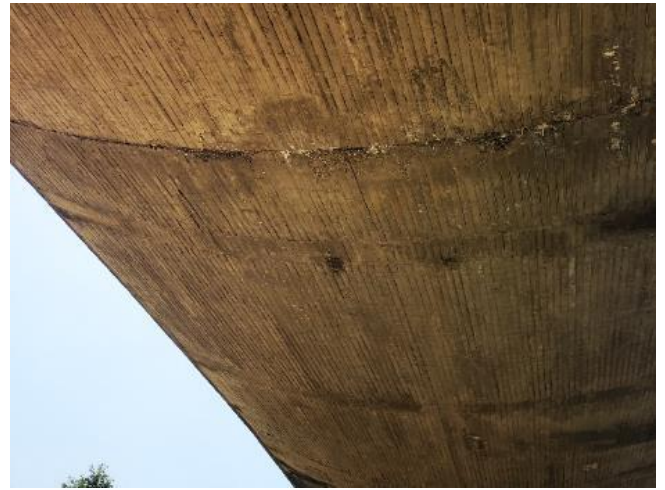
Figure 10. Bottom of deck deterioration due to rainwater drainage failure.

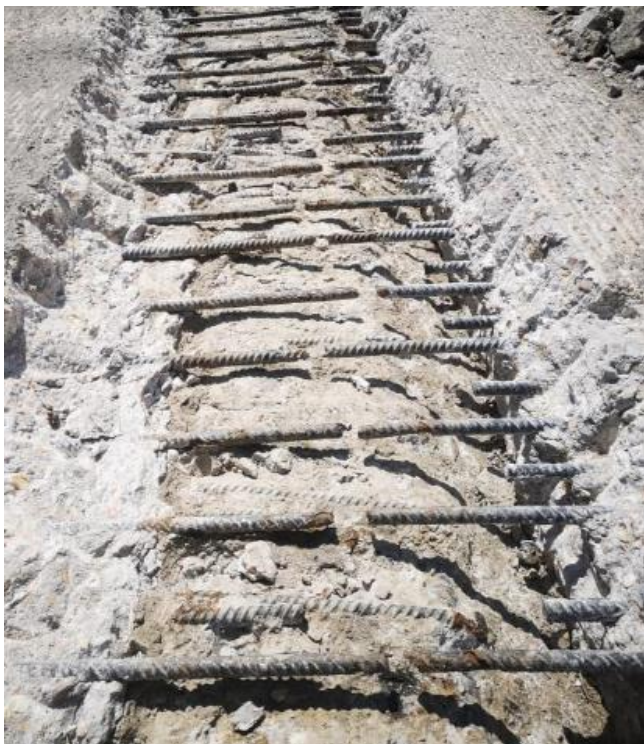
Figure 9. Systematic fractures of the transversal reinforcement due to expansion and corrosion processes under de-icing salts and runoff rainwater.

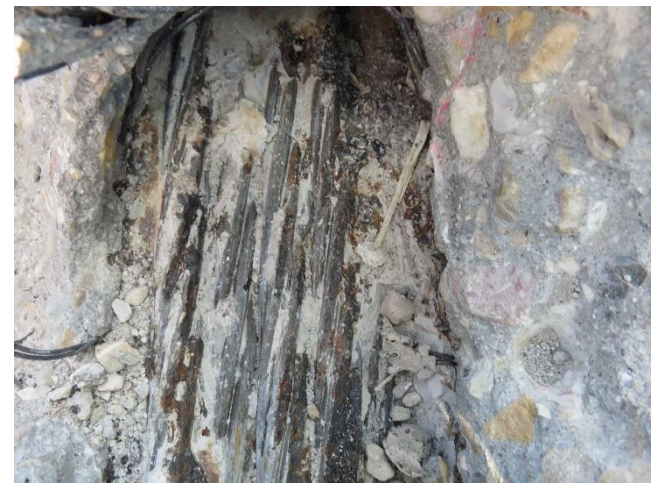
Figure 11. Corrosion of ducts and post-tensioning cables under the action of de-icing salts and a deficient duct injection.

Figures 11 and 12, corresponding to the demolished overpass at the highway in Madrid, show how the series of failures in the grouting system of ducts, together with the described water filtration

issues with salts triggered the collapse by corrosion under stress of an undetermined number of corroded prestressing tendons, which obliged the immediate demolition of a crucial structure for the accesses into Madrid.

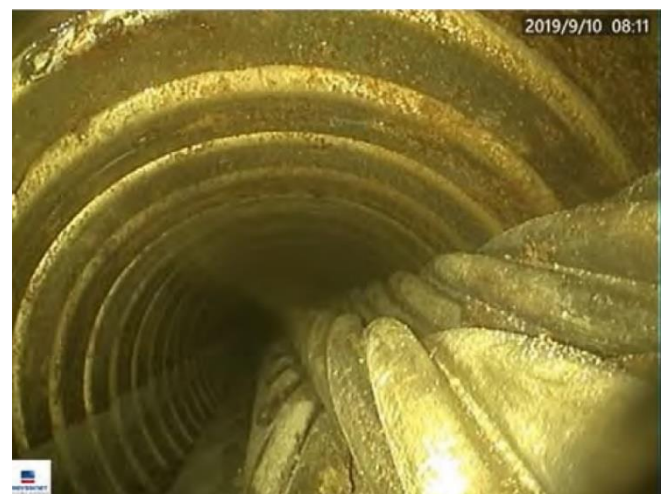
Figure 12. Photograph of the interior of the duct showing the incomplete filling by the grouting.

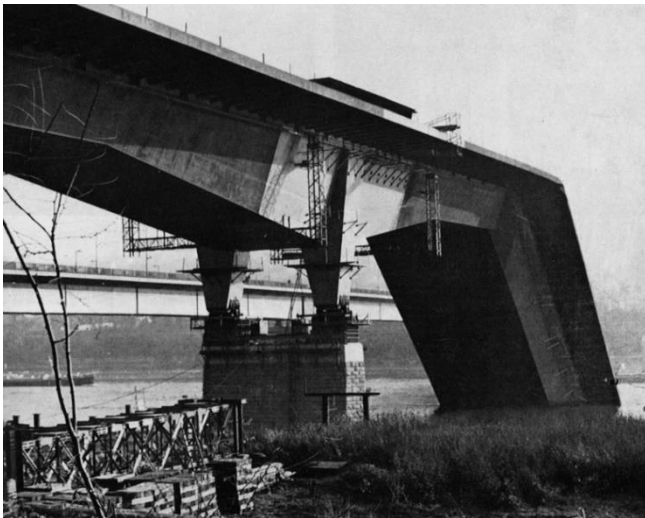
Figure 13. Accident during the cantilever erection of the Koblenz bridge (Germany) 1970

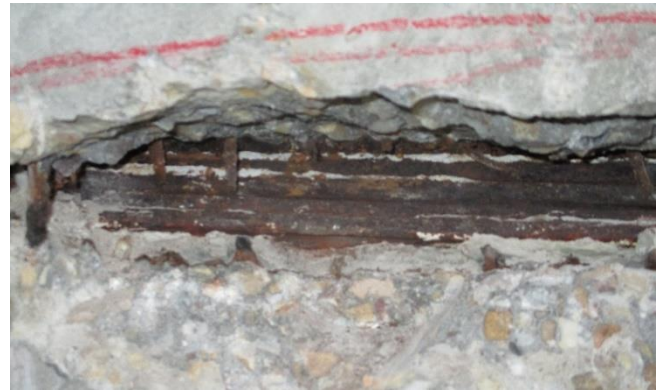
Figure 14. Lack of corrosion protection due to a not-conforming grouting of ducts.

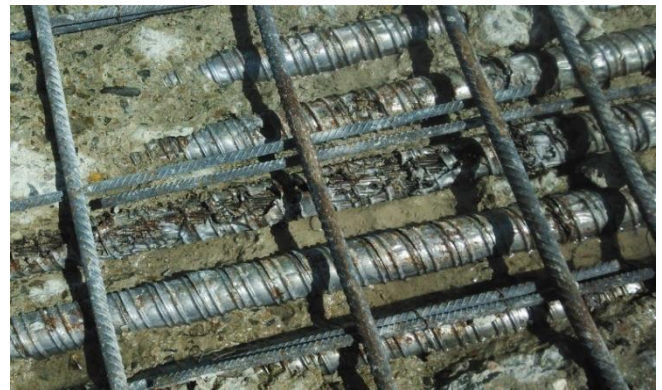
Figure 15. Lack of corrosion protection due to a not-conforming grouting of ducts.

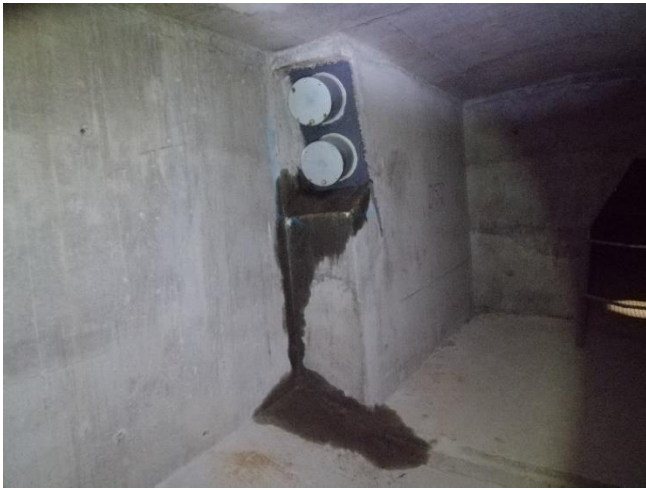
Figure 16. Water leakage through anchor caps of upper cables over piers on a box girder launched railway viaduct.

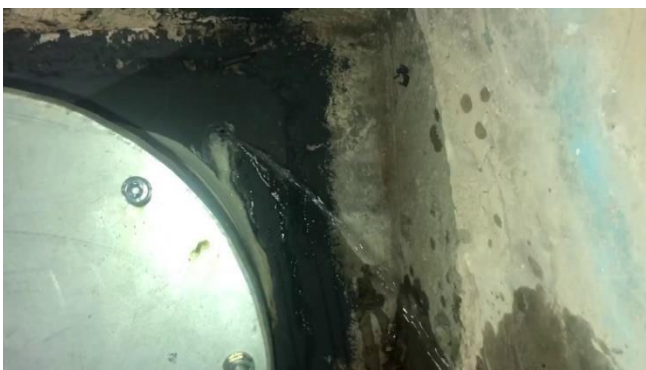
Figure 17. Continuous water flow when loosen some screws of anchors caps.

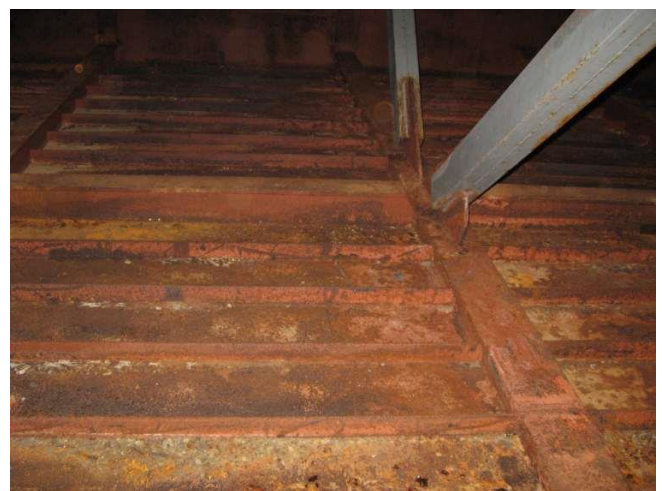
The advanced deterioration condition of the bridge of Mengibar, over the Guadalquivir river, can be observed on figures 18 and 19. An overall failure of the deck waterproofing system led to a water leaking that was accumulated due to the blockade of the steel stiffeners. This water built up between the bottom steel plate and the deck webs, producing an accelerated corrosion process with a net steel depth loss higher than the 5-10%.

The poor ventilation in box girders, together with the high humidity coming from the riverbed, caused frequent condensations inside the box girder, preventing the development of a self-protection layer that required frequent damp and dry cycles that never took place.

Figure 18. General corrosion at the bottom plates of the Mengibar bridge box girder.

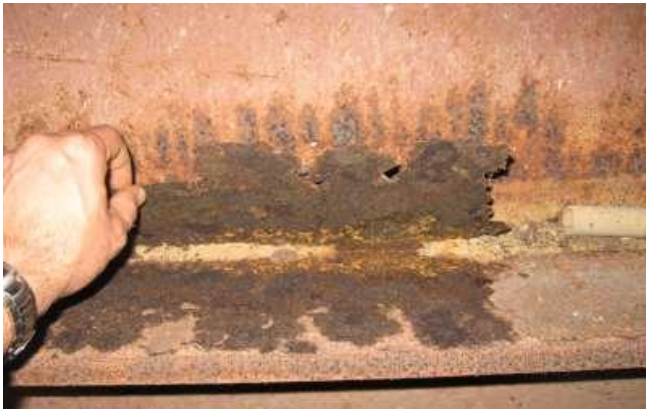
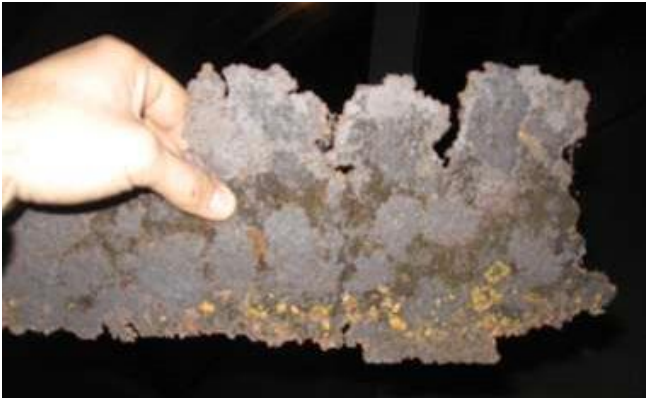
Figure 19a and b. Oxide thickness surface release due to the lack of weathering steels' own self-protection layer.

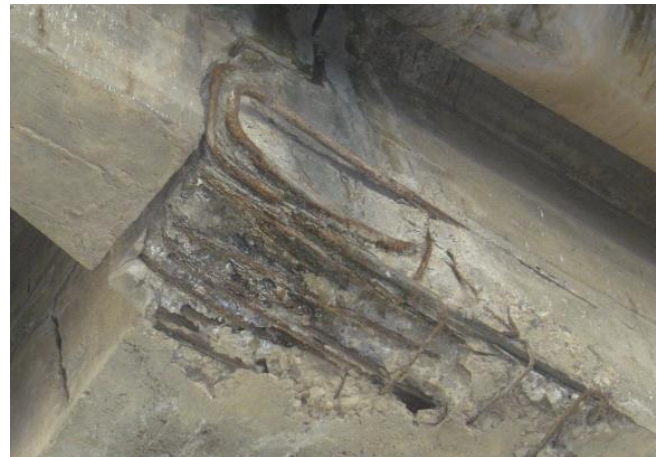
Figure 20. Concrete degradation of spalled corbels with general corrosion at reinforcements

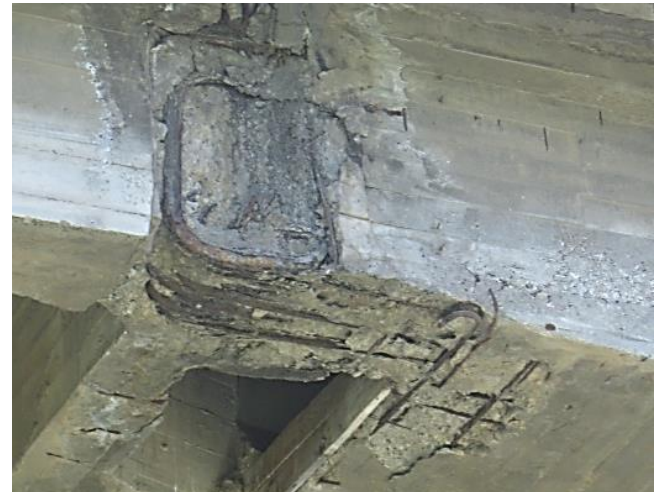
Figure 21. Concrete degradation of spalled corbels with general corrosion at reinforcements

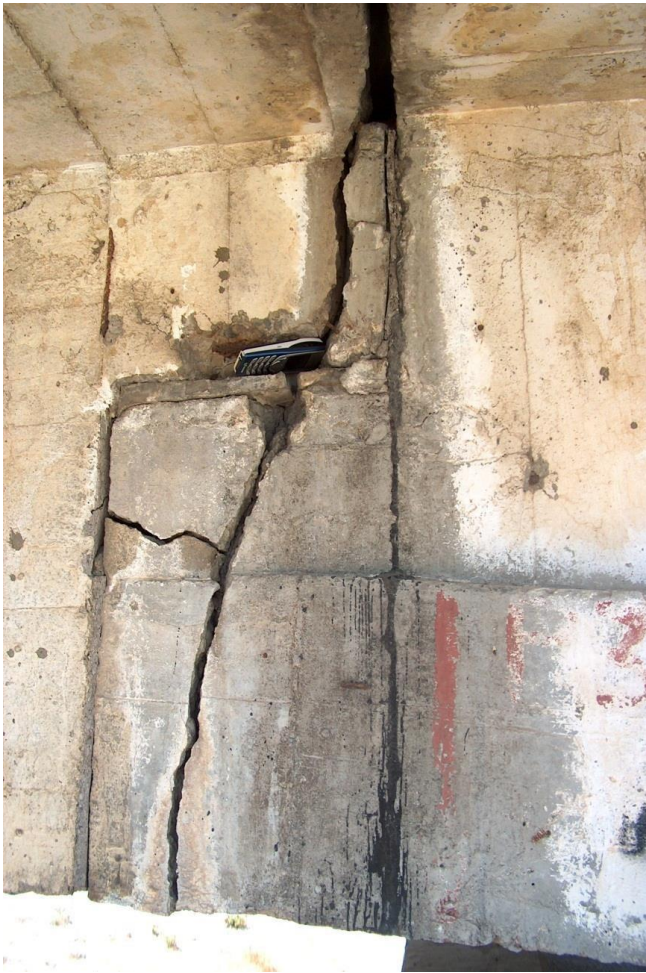
Figure 22. Corbel failure in a concrete bridge.

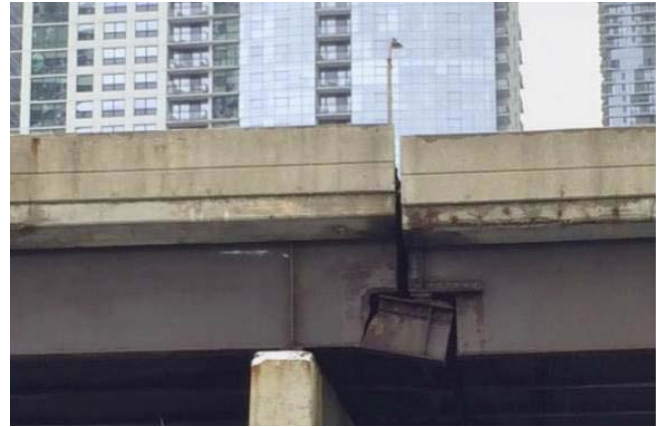
Figure 24. Failure by fatigue of a corbel in a steel bridge, Chicago.

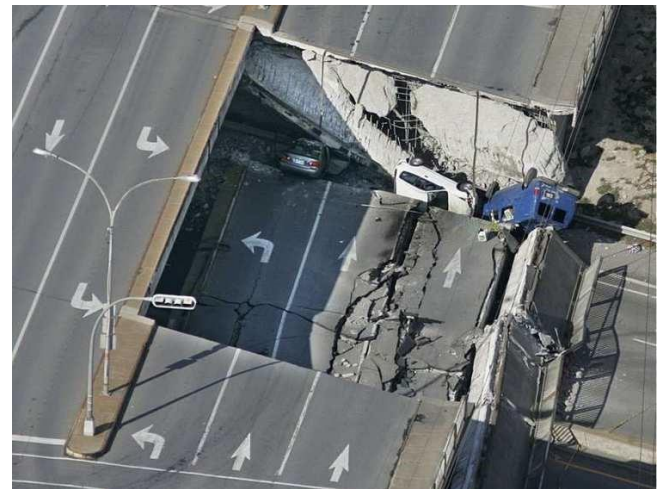
Figure 25. Concorde Overpass accident in Montreal due to the concrete corbel failure.

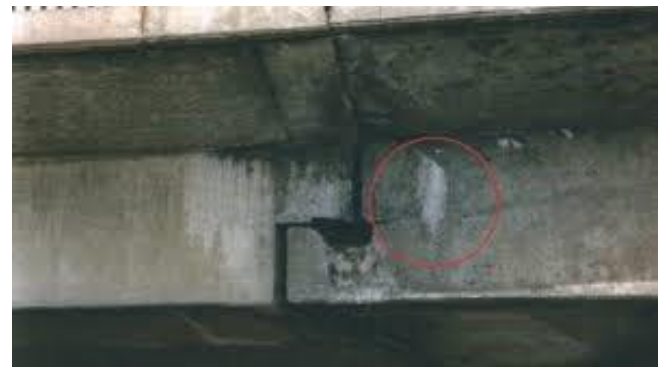
Figure 26. Detail of damages at the Montreal corbel before collapse.

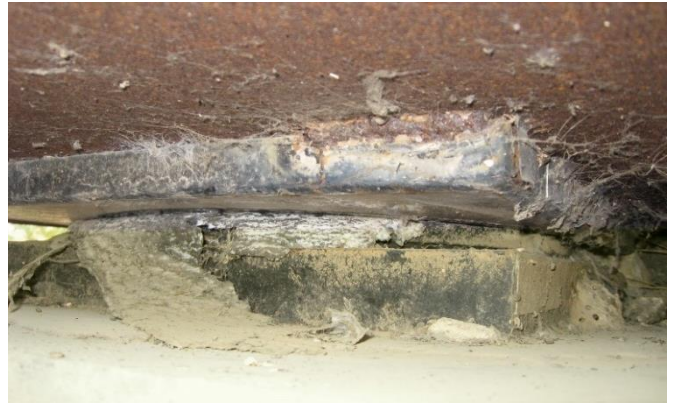
Figure 29. TPFE sheet removal of a POT-bearing.

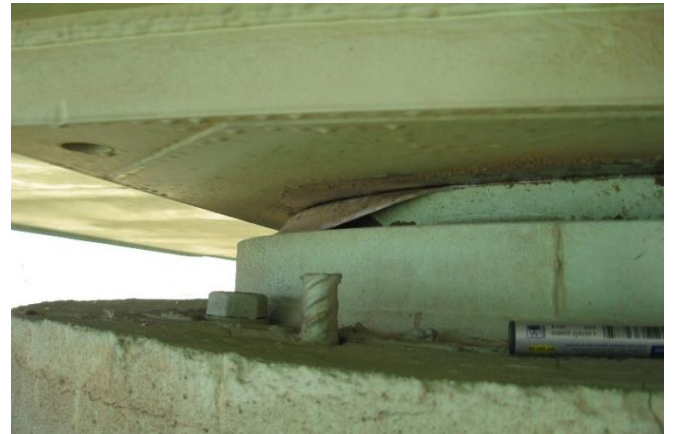
Figure 30. TPFE sheet removal of a POT-bearing.

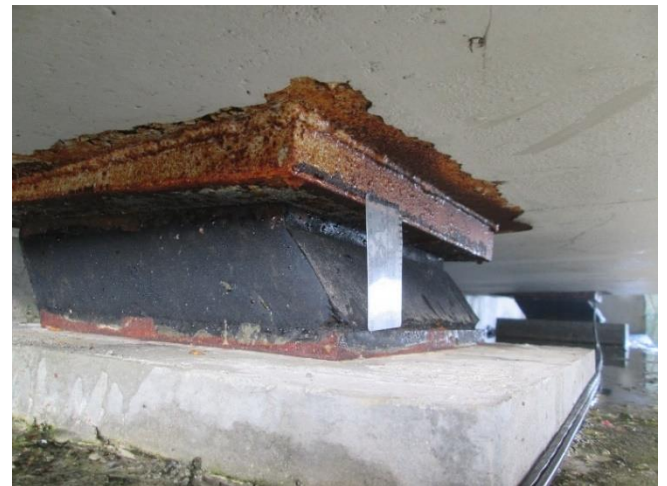
Figure 31. Excessive distortion at elastomeric bearings due to errors in the estimation of imposed deformation.

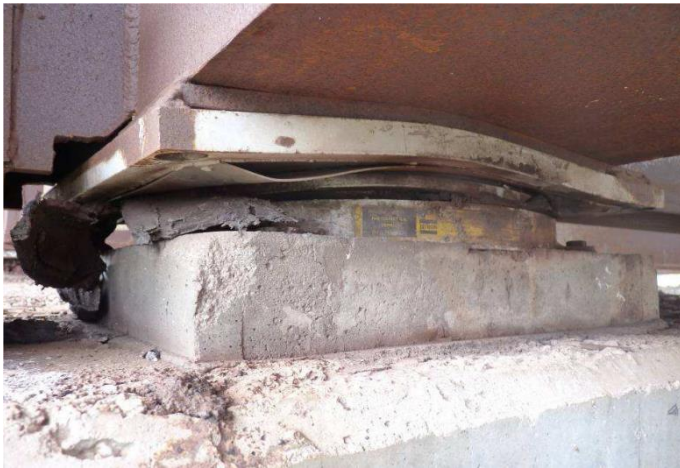
Figure 33. Contreras viaduct: bearing devices under out-of-service conditions.

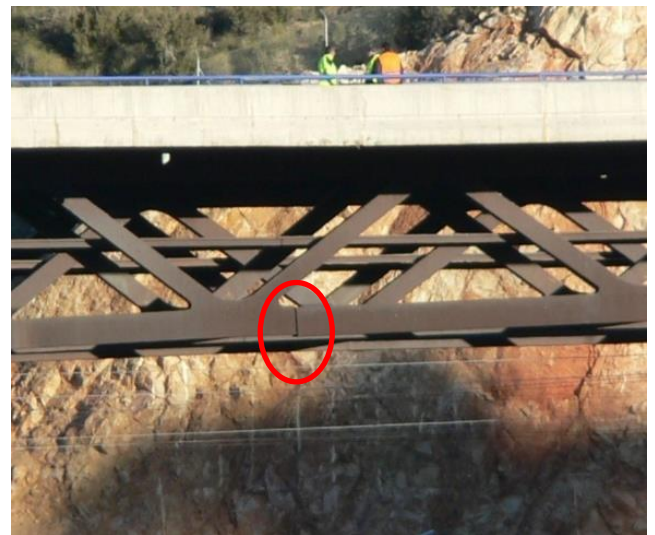
In 2013, during a routine inspection, a complete rupture of the welding connecting sections at the bottom chord of a composite truss in the lateral span of a viaduct located over the Contreras reservoir (with a main span of 170 meters), at the Highway A3 connecting Madrid-Valencia (Mediterranean coast), was detected.

Figure 35. Welding rupture at the truss traction chord.

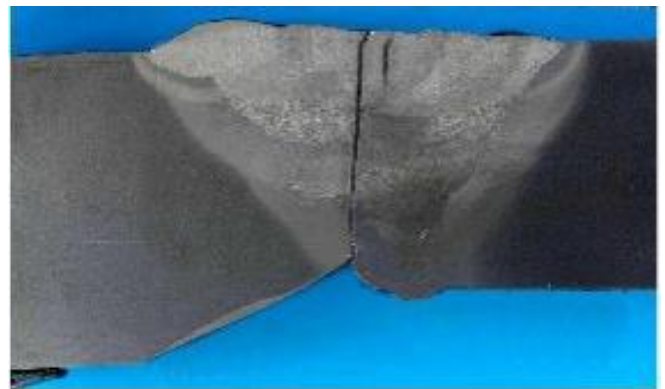
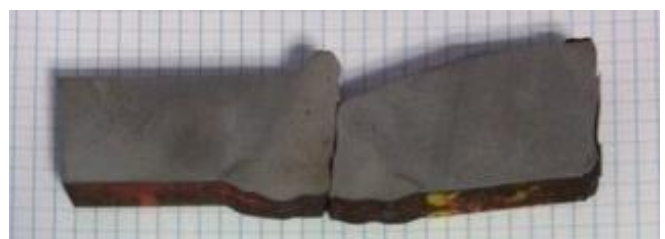
The laboratory inspection of the damaged welding identified the fatigue crack very clearly. The fissure started and developed due to the absence of backing plate, the deficient preparation of welding edges and inappropriate control of fit up between elements borders before starting welding.

Figures 38a and b. Fatigue fracture from a notch due to lack of backing

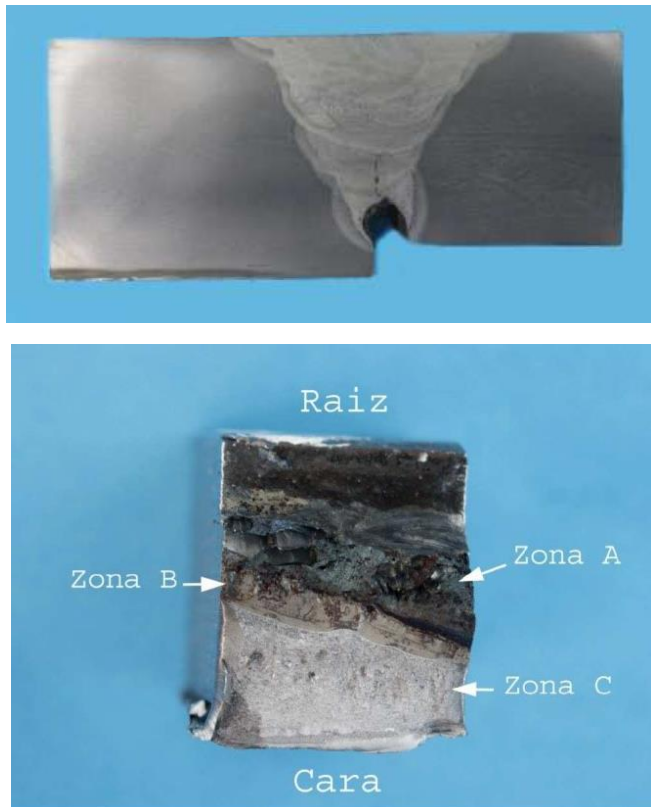
In another node open for inspection, a new fatigue cracking process in similar conditions to the damaged welding was detected.

Figure 39. Fatigue crack initiation coming from a notch due to lack of backing

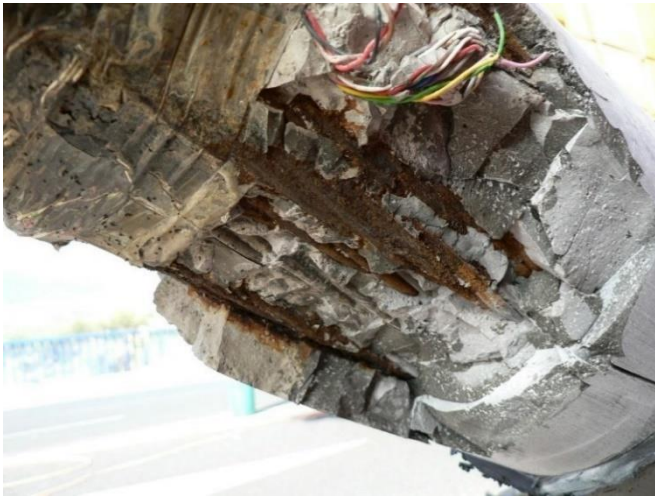
Figure 41. Observed damages in stay-cables with PHD ducts and mortar slurry

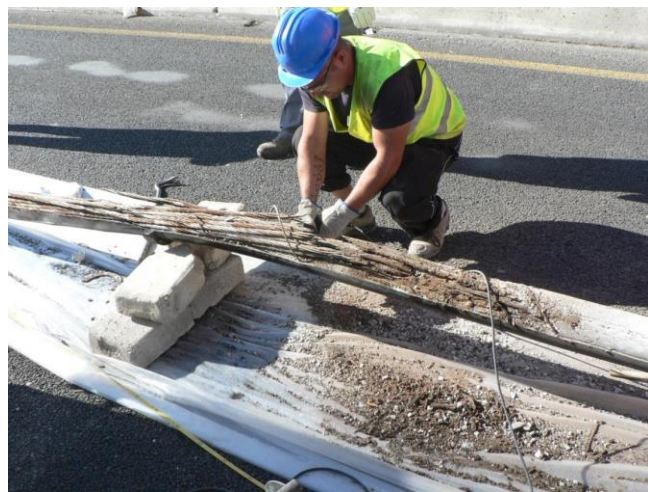
Figure 42. Observed damages in stay-cables with PHD ducts and mortar slurry

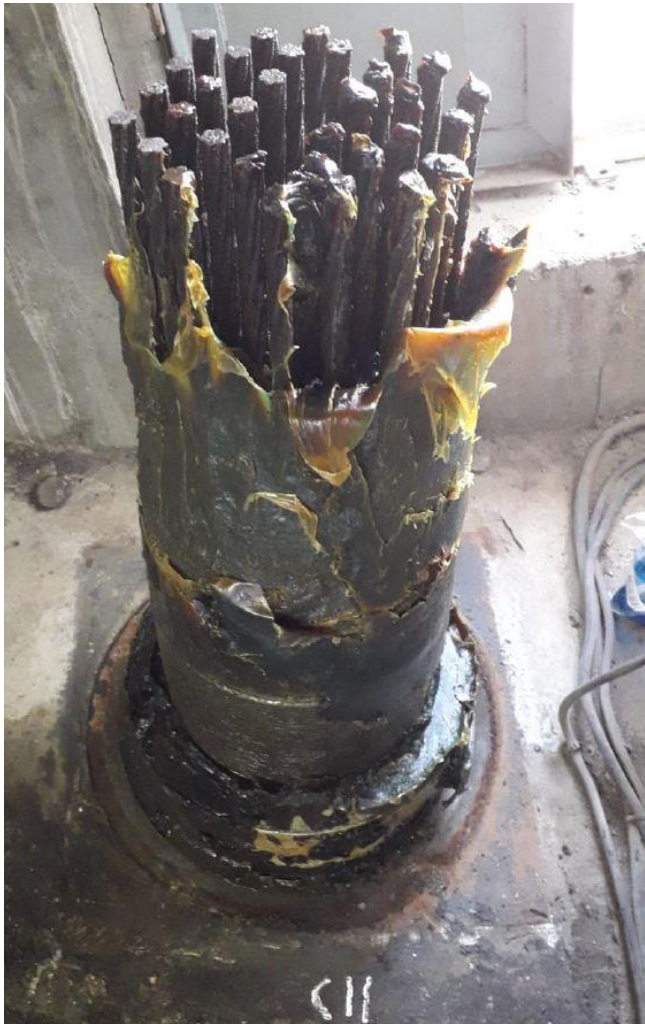
Figure 45. Generalized corrosion at the Alcoy bridge's broken cables (2016).

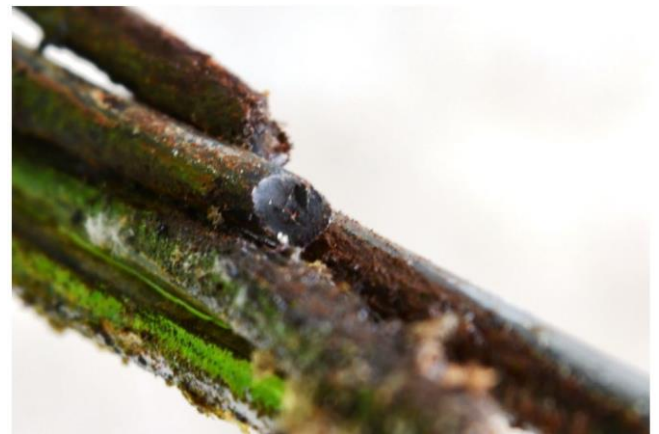
Figure 47. Corrosion detected at some tendons of the Centenary Bridge, 2018
