# SOME CASES OF PATHOLOGIES IN PRESTRESSED CONCRETE BRIDGES IN SPAIN. DIAGNOSIS, ANALYSIS, AND DECISION MAKING

**ABSTRACT:** During the last years, several problems and pathologies derived from flaws in the prestressing grouting system have been detected in Spain, which has led to costly repairing operations, and even to the demolition of viaducts placed, in many cases, in main arterial communication lines.

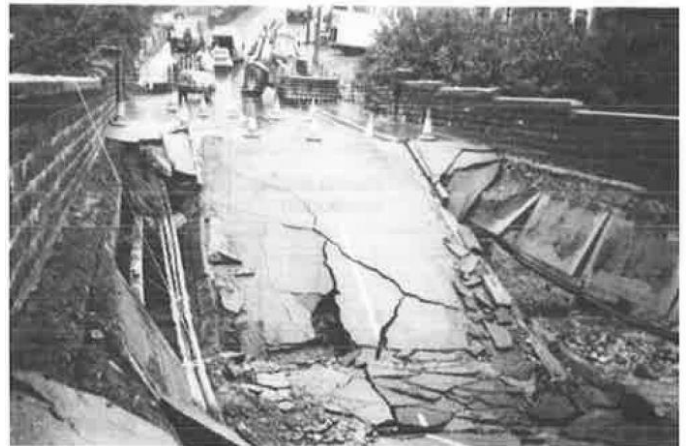
In 1992, a few years after the collapse of the Ynys-y-Gwas Bridge in Wales, the UK, due to corroded tendons, banned internal tendons and all UK designs, at that time, had to use external tendons.

Figure 1. Ynys-y-Gwas Bridge. Segmental Bridge collapsed in Wales. Source: Woodward, R.J. 1989. Collapse of a Segmental Post-Tensioned Concrete Bridge

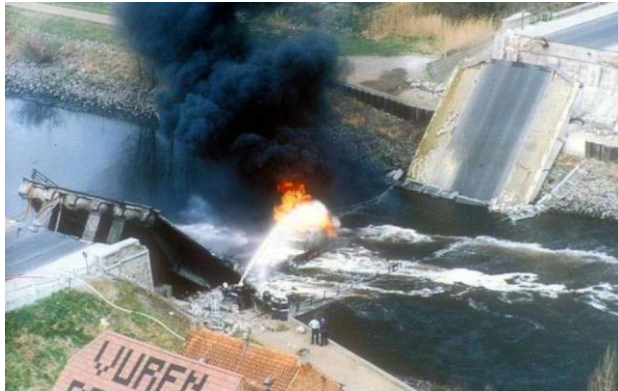
Figure 2. Bridge over river Malle in Belgium, where the failure of the tendon tie-down caused the bridge collapse in 1992. Source: *Durable Post-Tensioned Concrete Structures*. Concrete Bridge Development Group July 2011

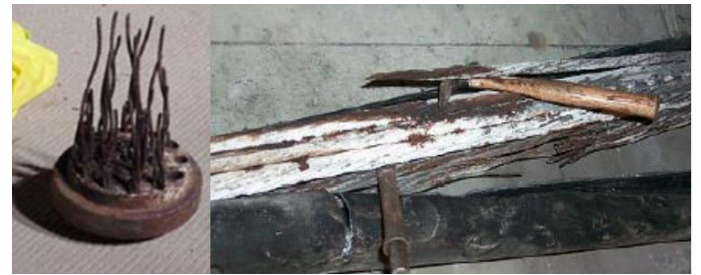
segmental bridge of 5,8 km of length and 41,45 m typical spans. In this case, the official report showed the bad grout quality and a fill tendons’ failure as the source of the pathology.

Figure 5. Detailed view of an anchor plate tendon and of a damaged tendon. In both cases, corrosion and grouted problems were detected. Source: Mid-Bay Bridge Post-Tensioning Evaluation

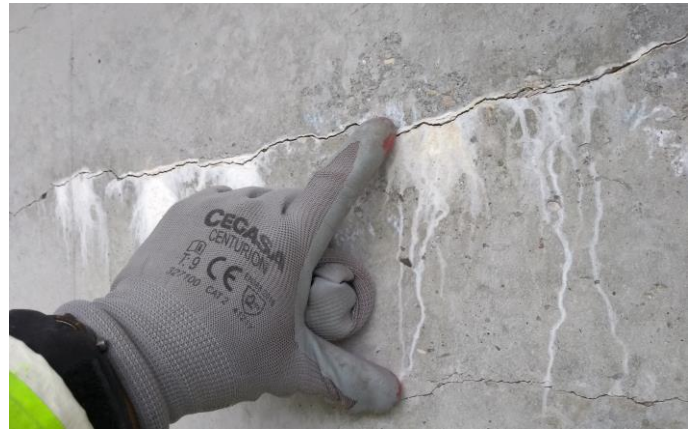
Almost all the V-shape beams showed atypical cracks, all of them with the same pattern, beginning in the corbel bearing and going to the bottom section in the middle span. In addition, some cracks had evidence of water circulation, a fact that was very strange and suspicious.

Figure 8. Detailed view of the cracks of the V-Shape beams. Evidence of water circulation and white carbonates spots.

The inspection result was very conclusive: several ducts had corrosion wires, and a few of them showed a severe corrosion stage. The prestressing damage was estimated about 40%. Strengthening solutions were studied and analysed, but due to the important damage percentage, and as the new code design carries a very complex solution, the final decision was the access span substitution.

The orography of the environment was very irregular, with more than 35% of average slope, and there was not an easy underbridge access. The three-span substitution was studied with cranes and a heavy-lifting system, but it was finally executed with a launching girder. This system was used for the deconstruction of the existing bridge. This operation was more complex and delicate than the typical construction due to the additional weight of the beam-slab section.

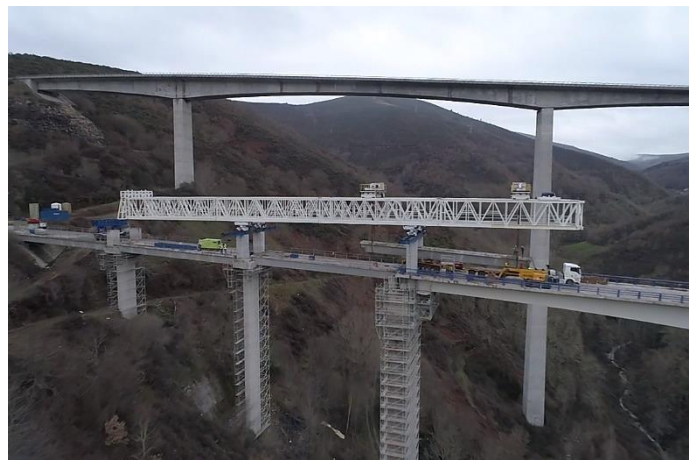
Figure 9. Ruitelán first deconstruction V-shape beam with a launching girder.

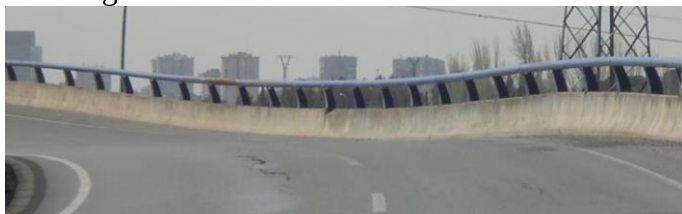
In this case, the bridge suffered from a well known Alkali-Silica Reactivity (ASR) and manifested several cracks and deformations, mainly in the main span. These problems had been studied for a long time.

Previous months after the intervention, an accelerated deformation was detected in the main span and this was the signal for the intervention. An invasive special inspection was carried out to have more information about the concrete mechanical and chemical properties, the steel reinforcement and, mainly, about the prestressing system of the bridge. In this sense, all the pavement was retired to be able to inspect the top slab, and to access the top points of the ducts prestressing.

Figure 11. Up to 60 cm deflection in main span. Perfectly visible along the bridge.

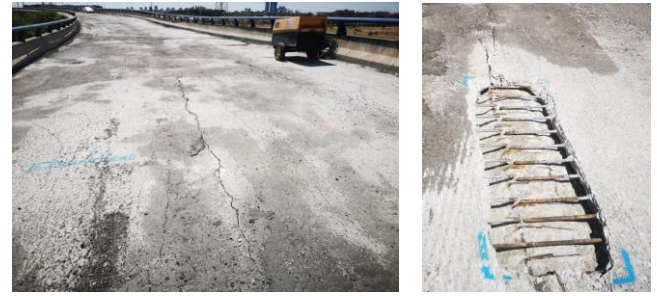
After retiring the pavement, several cracks, some of which were very big, were discovered on the top slab, in the contiguous main span. The depth of these cracks was of many centimetres and the reinforcement bars were broken/cut where the cracks were bigger. Chemical and mechanical tests showed that the failure of the mechanism had begun with the non-controlled concrete cracking, which had been generated by the ASR, where the water with de-icing salts had

accumulated and produced the total corrosion of the rebars until their local disappearance.

Figure 12. On the left picture, general cracking of the top slab bridge. On the right one, reinforcement bars sectioned along the bigger cracks.

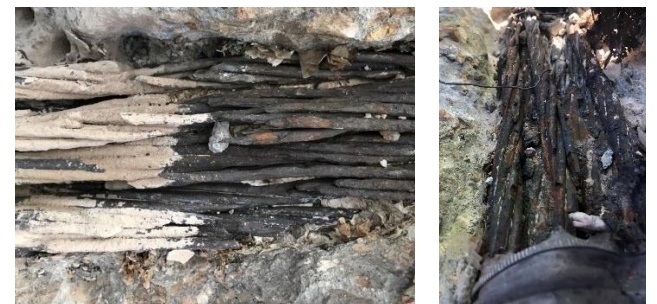
The prestressing inspections focused on pier sections, coinciding with the top points of the prestressing elevation. Couplers sections were also investigated but their depth made that investigation very complex and difficult. The inspection was carried out hydrodemoliting the concrete to access the top ducts points over piers and with a boroscope in case there were voids or grouting failures. Several ducts with grouting problems were detected and corrosion prestressing wires appeared too. In some cases, the wires corrosion was so several, that some of them were completely broken.

Figure 13. Grouting voids with severe corrosion and broken wires and strands.

After considering all the detected pathologies and the uncertainties about the real integrity of the bridge, the global analysis resistance of the structure was alleged to be very unfavourable and critical to ensure a minimum resistance to permit the strengthening of the viaduct, so finally, the decision was to replace the bridge.

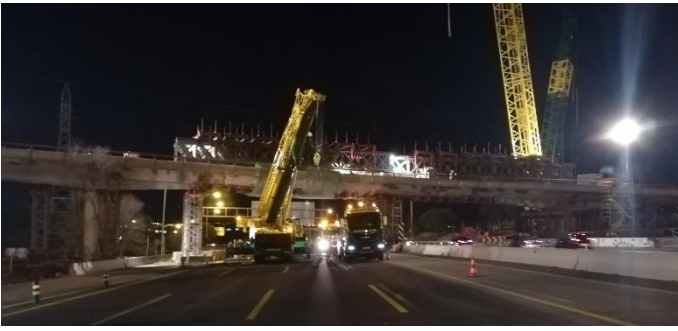
Figure 14. Deconstruction general view.

Again, the deconstruction of the existing viaduct was a critical operation by the uncertainty about the residual mechanical resistance of the bridge. For the main span, a hanging beam was used to ensure the stability of the bridge. The span was cut off in pieces about 2000 kN and lowered with cranes. This operation was developed along one full weekend to ensure the traffic security and the operation viability itself.

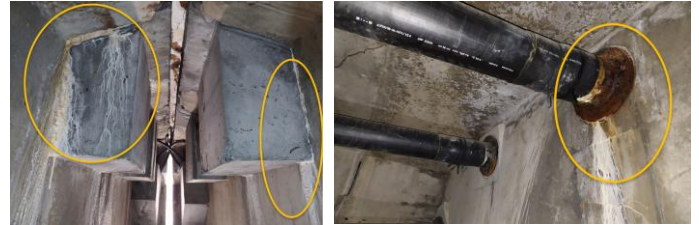
An inside inspection of the box girders detected water circulation along the protection mortar prestressing blocks, which caused a lot of white carbonates spots. This pathology appeared in almost every anchor protection blocks. In addition, one complete failure tendon was detected and water circulation evidence inside the HDPE ducts was also found.

Figure 17. On the left picture, detailed protection anchorages blocks with water circulation. On the right one, evidence of water circulation along the interior prestressing duct.

Considering the critical failure of the bridge, traffic restrictions were established, and a reduction of the pavement thickness was carried out too.

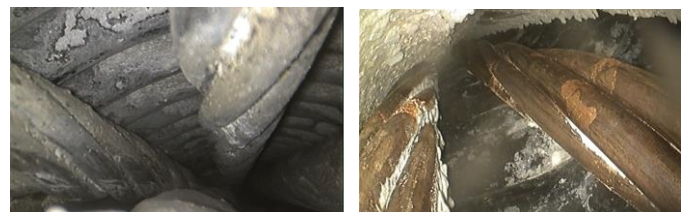
The inspections' results showed that a very important number of tendons had serious corrosion pathologies. They had a double origin. On the one hand, there were problems and defects of the grouting ducts, specially inside the upper anchors, helped, probably, by the longitudinal slope. And on the other hand, there was water circulation with de-icing salts along the dilatation joints of the bridge and consequently, along the mortar protection blocks. The damages were classified in inside defects, when they had taken place in the interior of the anchorage block and could be detected only by drilling and borescope, and outside defects, when they were perfectly visible without any special issue.

Figure 18. Interior anchorage block inspection by borescope. Significant grout voids detected with strand corrosion. Source: Freyssinet.

In the first phase, 2 additional tendons were implemented. This strengthening gave an additional security margin and allowed the replacement of the tendons with total security and without resistance uncertainties in the second phase.

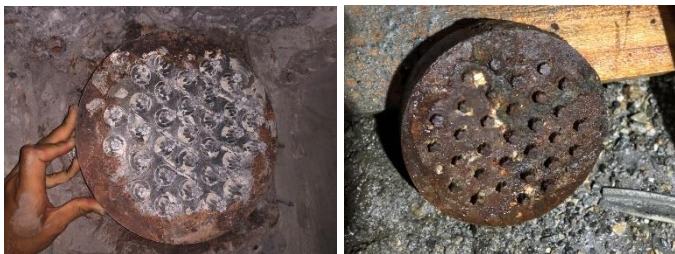
Figure 19. Exterior aspect anchorage block after mortar withdrawal. Different corrosion levels were discovered.

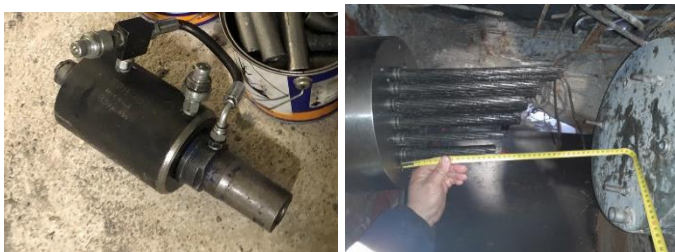
Figure 20. On the left hand, mono strand jack of reduced dimensions. On the right hand, free space between anchors block. Detail while the stressing operation.

The tendons replacement wasn't an easy operation. The free space between end-beams spans was very reduced, around 70 cm, and made the solution and the performance very difficult. This space was totally insufficient to use a multi-strand jack, so a reduced mono strand jack of 30 cm and 45 mm of stroke was designed. In any case, the limited space forced to stress the strands in more than 10 steps.

The new strands have the maximum durability standards: individually greased and sheathed strands involved in a global grouted HDPE duct. Grouting and anchors blocks were specially designed and controlled during its execution. Finally, an extra waterproofing protection was designed to prevent the water access and circulation along the protection blocks.
