# Some lessons of more than 20 years of inspection, maintenance and rehabilitation of bridges in Spain

Francisco Millanes Mato

Ignacio Pulido Sánchez

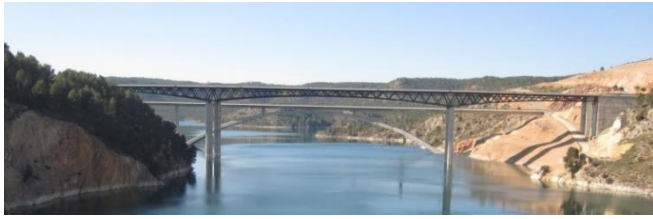
Figure 32. Contreras viaduct, 170-meter span composite truss.

In 2013, during a routine inspection, a complete rupture of the welding connecting sections at the bottom chord of a composite truss in the lateral span of a viaduct located over the Contreras reservoir (with a main span of 170 meters), at the Highway A3 connecting Madrid-Valencia (Mediterranean coast), was detected.

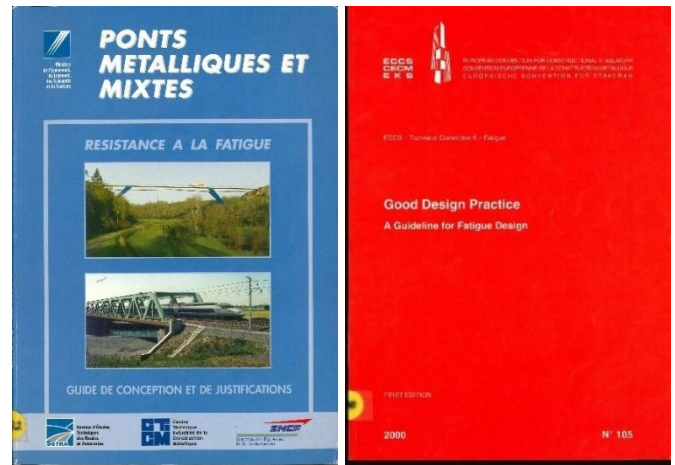
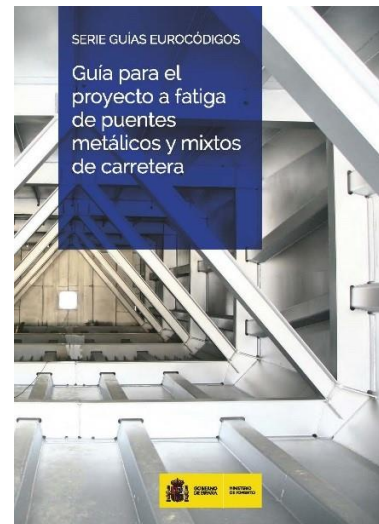
Figure 40. Fatigue design guides (SETRA, ECCS, Spanish Ministry)

IDEAM was also commissioned by the Spanish Ministry to draft a 'Guide for the fatigue design of steel and composite bridge' under Eurocodes and following similar initiatives by SETRA, ECCS, etc.

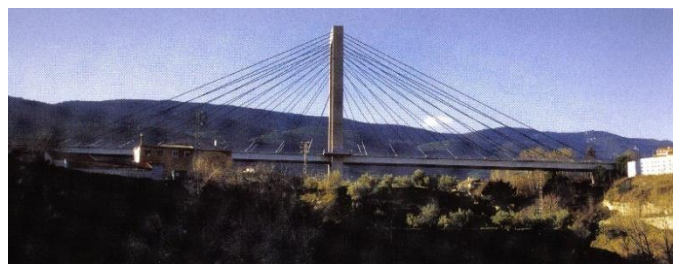
In 2016, the sudden failure of one stay cable at the 132-meter main span Alcoy bridge, put in service in 1987, led to a complete replacement of its stay-cable system.

Figure 44. Alcoy stay-cable bridge (1987).

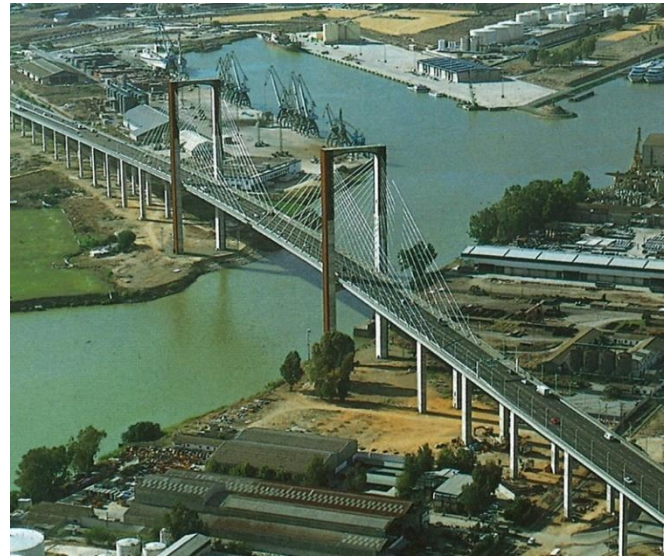
Subsequently, the condition of the Centenary Bridge's stay cables was inspected. The bridge, inaugurated in 1992 in Seville on the occasion of the Universal Exhibition, over the Guadalquivir river and has a main span of 264 meters. The inspection detected the start of the corrosion processes development at stay cables. Although this process did not affect the structural safety yet, it was recommended to draft an urgent replacement project of the stay cables, which was completed in 2019, allowing works to start in the second half of 2020. The project and future construction support services has been developed by IDEAM, author of the original project that dates back 30 years, in JV with FHECOR.

Figure 46. Centenary cable-stayed bridge in Seville, 1992.
