# SOME CASES OF PATHOLOGIES IN PRESTRESSED CONCRETE BRIDGES IN SPAIN. DIAGNOSIS, ANALYSIS, AND DECISION MAKING

**ABSTRACT:** During the last years, several problems and pathologies derived from flaws in the prestressing grouting system have been detected in Spain, which has led to costly repairing operations, and even to the demolition of viaducts placed, in many cases, in main arterial communication lines.

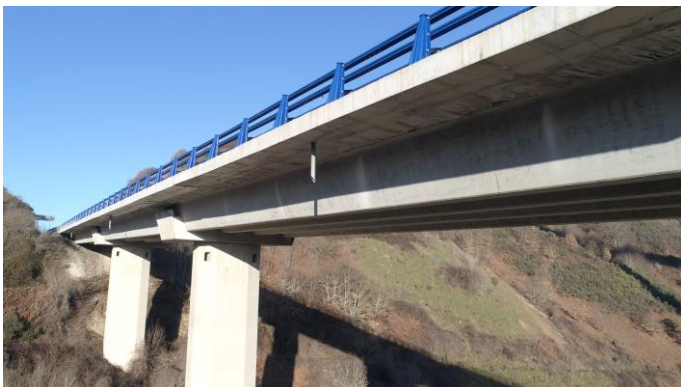
Figure 7. Ruitelán detailed view of north access viaduct.

Almost all the V-shape beams showed atypical cracks, all of them with the same pattern, beginning in the corbel bearing and going to the bottom section in the middle span. In addition, some cracks had evidence of water circulation, a fact that was very strange and suspicious.

The inspection result was very conclusive: several ducts had corrosion wires, and a few of them showed a severe corrosion stage. The prestressing damage was estimated about 40%. Strengthening solutions were studied and analysed, but due to the important damage percentage, and as the new code design carries a very complex solution, the final decision was the access span substitution.

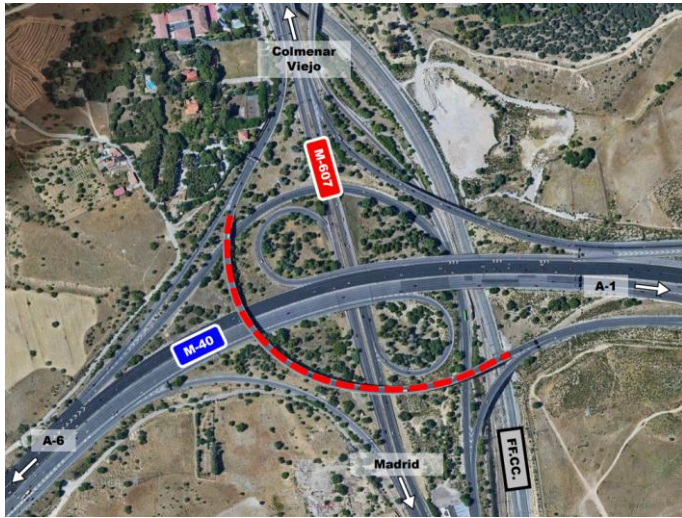
Figure 10. General plan overview of the viaduct and the environment.

In this case, the bridge suffered from a well known Alkali-Silica Reactivity (ASR) and manifested several cracks and deformations, mainly in the main span. These problems had been studied for a long time.

After considering all the detected pathologies and the uncertainties about the real integrity of the bridge, the global analysis resistance of the structure was alleged to be very unfavourable and critical to ensure a minimum resistance to permit the strengthening of the viaduct, so finally, the decision was to replace the bridge.

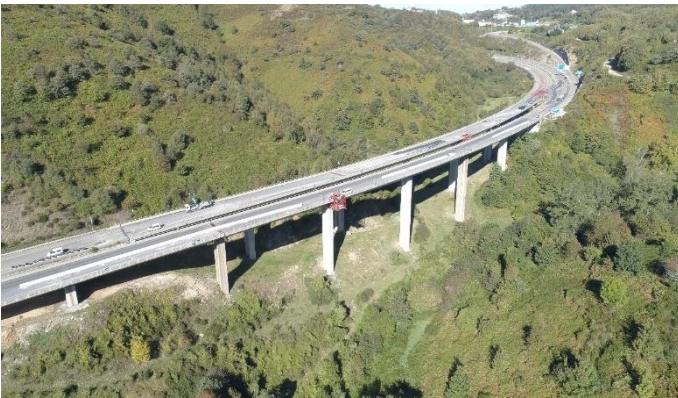
Figure 15. Castro viaducts general overview.

An inside inspection of the box girders detected water circulation along the protection mortar prestressing blocks, which caused a lot of white carbonates spots. This pathology appeared in almost every anchor protection blocks. In addition, one complete failure tendon was detected and water circulation evidence inside the HDPE ducts was also found.

Considering the critical failure of the bridge, traffic restrictions were established, and a reduction of the pavement thickness was carried out too.

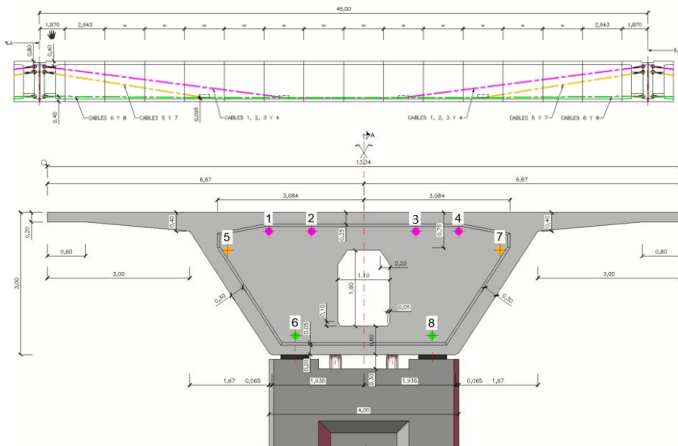
The prestressing system is formed by 8 tendons, 4 near the top slab, 2 on the corners of top webs part, and 2 more over the bottom slab.

Figure 16. Span general elevation and cross section with the prestressing anchorages position.
